SURVEY REPORT VESSEL: xxxxxxxxxxxx

Prepared by: Bill Gladding SAMS-AMS® #810
Society of Accredited Marine Surveyors

SURVEY PURPOSE: prepurchase
FILE #: 2024-11-25 Lagoon 42 2020

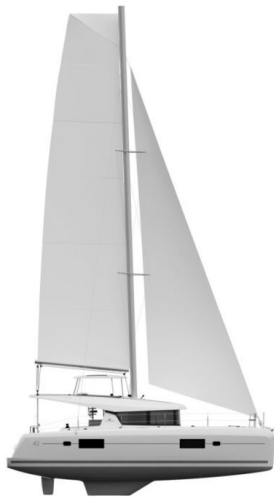
Drawings from sailboatdata.com

Exterior arrangement – catamaran sailboat noted the following:
