SURVEY REPORT VESSEL: xxxxxx

Prepared by: **Bill Gladding SAMS-AMS® #810**
Society of Accredited Marine Surveyors

SURVEY PURPOSE: prepurchase
FILE #: 2024-06-05 Pacific Seacraft 37 1988

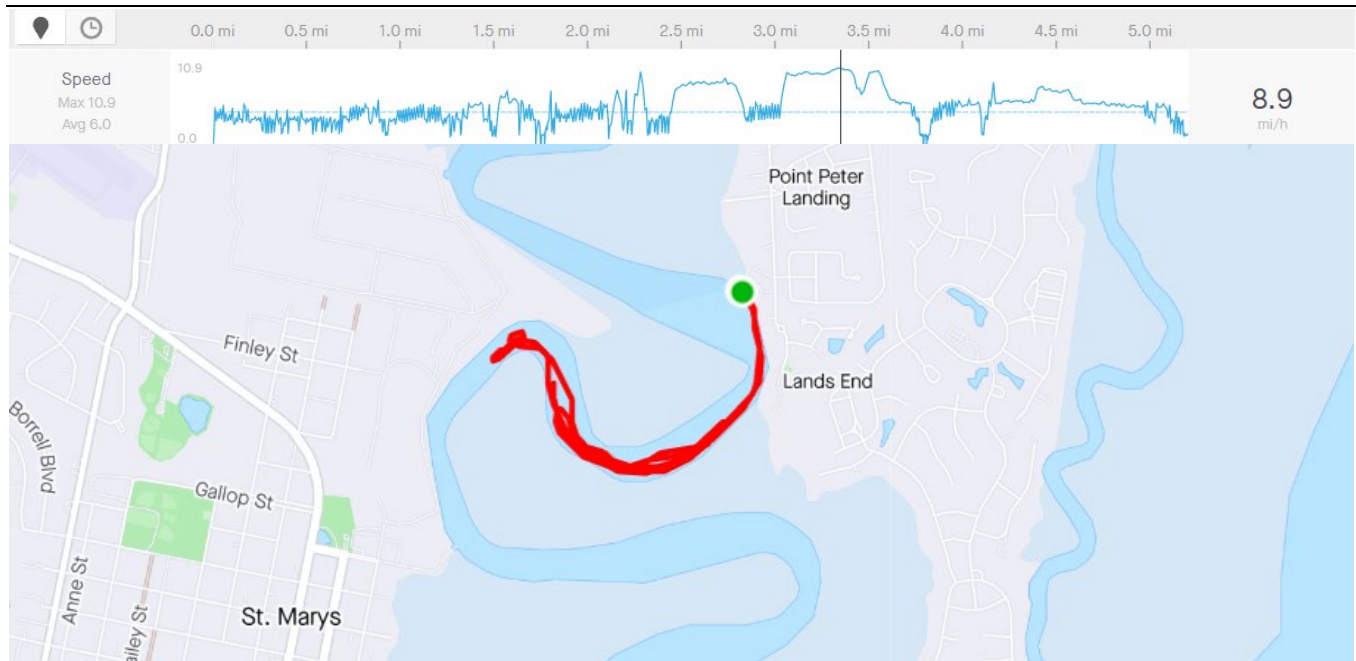
TRIAL RUN

- Date – June 6, 2024
- Location – St. Mary's River
- Conditions:
 - Temperature °F (80)
 - Wind direction & velocity mph (SW @ 5.4)
 - Wave height estimated (calm)
- Duration – approximately one hour 20 minutes
- Number of passengers - three
- Tanks levels:
 - Fuel – 50%
 - Water – 0%
 - Waste – 0%
- Hull performance – normal. Sails were raised but winding river, shallows and current prevented meaningful evaluation of sailing performance. Engine RPMs – speed MPH noted as follows:
 - 2,600 – 7.2
 - 3,200 – 8.2
 - Full power – 3,600 – 8.7
 - Full power course reversed – 7.9
- Engine performance:
 - Cold start - normal
 - Wide open throttle rpms (3,600 desired) – 3,600
 - Temperatures and pressures – maximum temperature reached 178 degrees F. No alarms occurred
- Comments – uneventful trial-run
